List of info

TIPS & TRICKS

Model: DTR-4.6 (for ALL unit service info)

Subject: Input work Digital lit on display, No audio output to speakers.

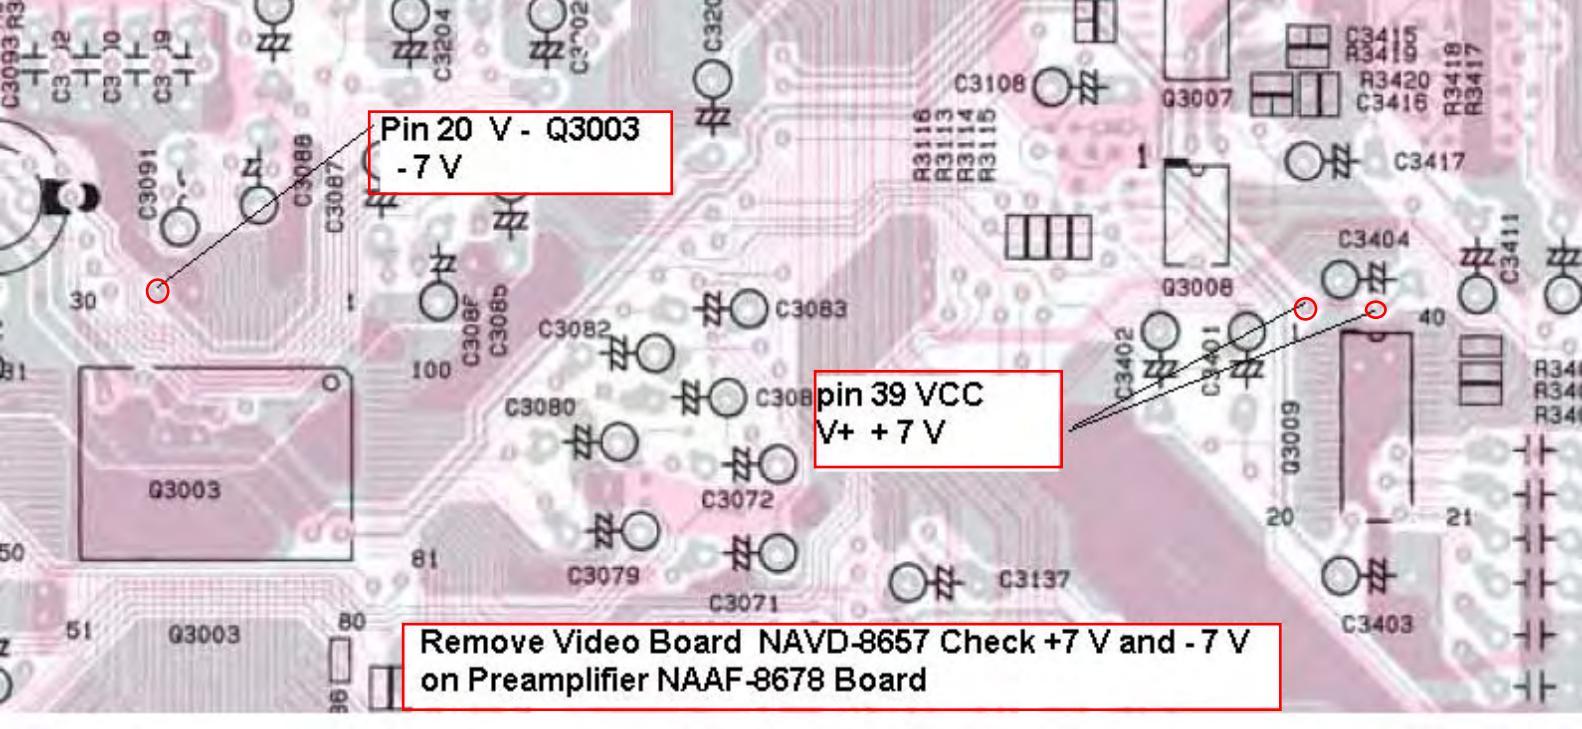
Symptom: Use DVD RCA audio input, no audio signal at Pin 4,5,6,7 at P3101B. (Check with Scope should have 2.5 V DC with 0.2 V pp audio ** USE SCOPE TO CHECK ** Missing Output from pin 8 to pin 15 on P3101B digital out Should be ^o <u>v</u> ₩₩₩₩₩ <u>i</u> 0.4 v pp 0 V dc with 0.4 V pp) Solution: First check microprocessor Q701 control signal output. (5 V.) **R267. R268 VOLSTB and VOLCLK should have 5 V dc with** 5 V 5 V pulse down to 0 V when adjust volume control. (also at P3105B) **0** V **R659 VOLDAT** should have 0 V dc with 5 V pulse when adj volume. If low Remove pin 58,59,60 On Q3003 if pulse was low. To check control signal back Up to 5 V. If control signal still low Q701 may be def. If yes have 5 V pulse Q3003 was leaking Replace new IC. Next check +7 V and -7 V power supply on Q3003 and Q3009. Remove XM Radio NARF-9688 and VIDEO Board NAVD-8657. Check R3127 right side Reg Q3005 out pin 1 should be + 7 V. If low or +2.5 V Q3003 or Q3009 may be leaking. Remove pin 19 or VCC pin 39 on Q3009 and Check. Same as Q3006 out pin 3 ,Right side R3128 should be – 7 V. if low Replace def. Q3003 or Q3009. If control signal is good CD audio signal go in to Q 3003, +7 v And - 7 V all good but no ADRT-, ADRT+, ADLT- and ADLT+ audio out **Replace Q3003 input select IC.** Check next page ! Ω

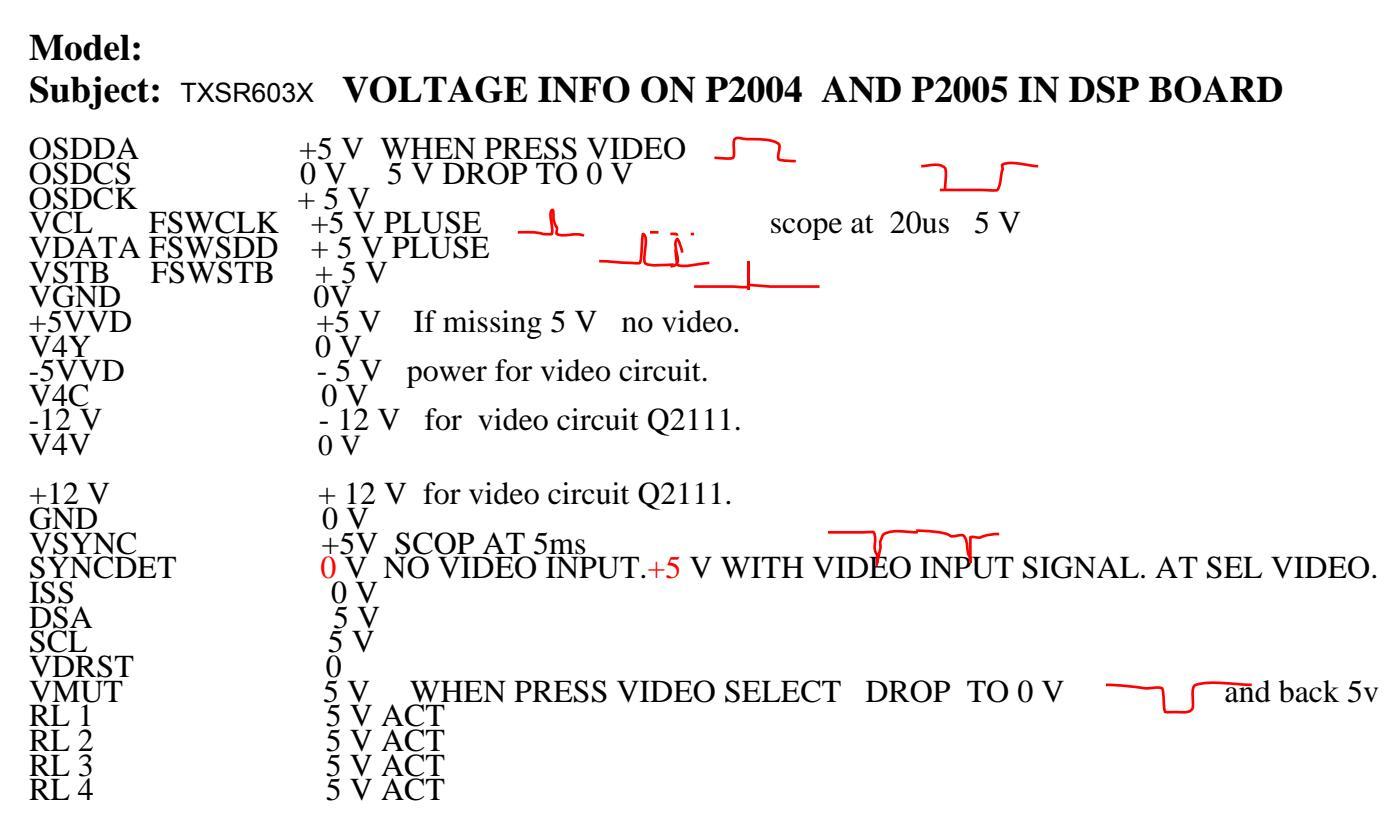
If missing red control pluse Q701 microprocess may be def. if audio switch ok . 5 v pluse should be good.

When missing +5 VVD check U02 NAAF-8523 Q5654, Q5650 and Q5653 +12 power supply.
use DVD RCA video input no monitor video out.
check Q2111 pin 1 -12 v pin 30 + 12 V, pin 14,16 and pin17 have 5 v pulse when press DVD, Video1 than DVD.
with viode signal connect input !! pin 29 should be 0V, pin27 R-S3 +5V, R-s4 -5v, R-S5 -5v, R-s6 +5 V
R-S7 +5 V, R-S8 - 5V, R-S1 5V and RS2 5V.
When Q2111 is good power supply is right.control pluse ok 5 v. missing R-S3 5 v replace Q2004

DVD viseo RCA signal in to Q2001 pin3 out from pin1 to Q2012 E. when R-S3 is 5 V. Video go out to Monitor

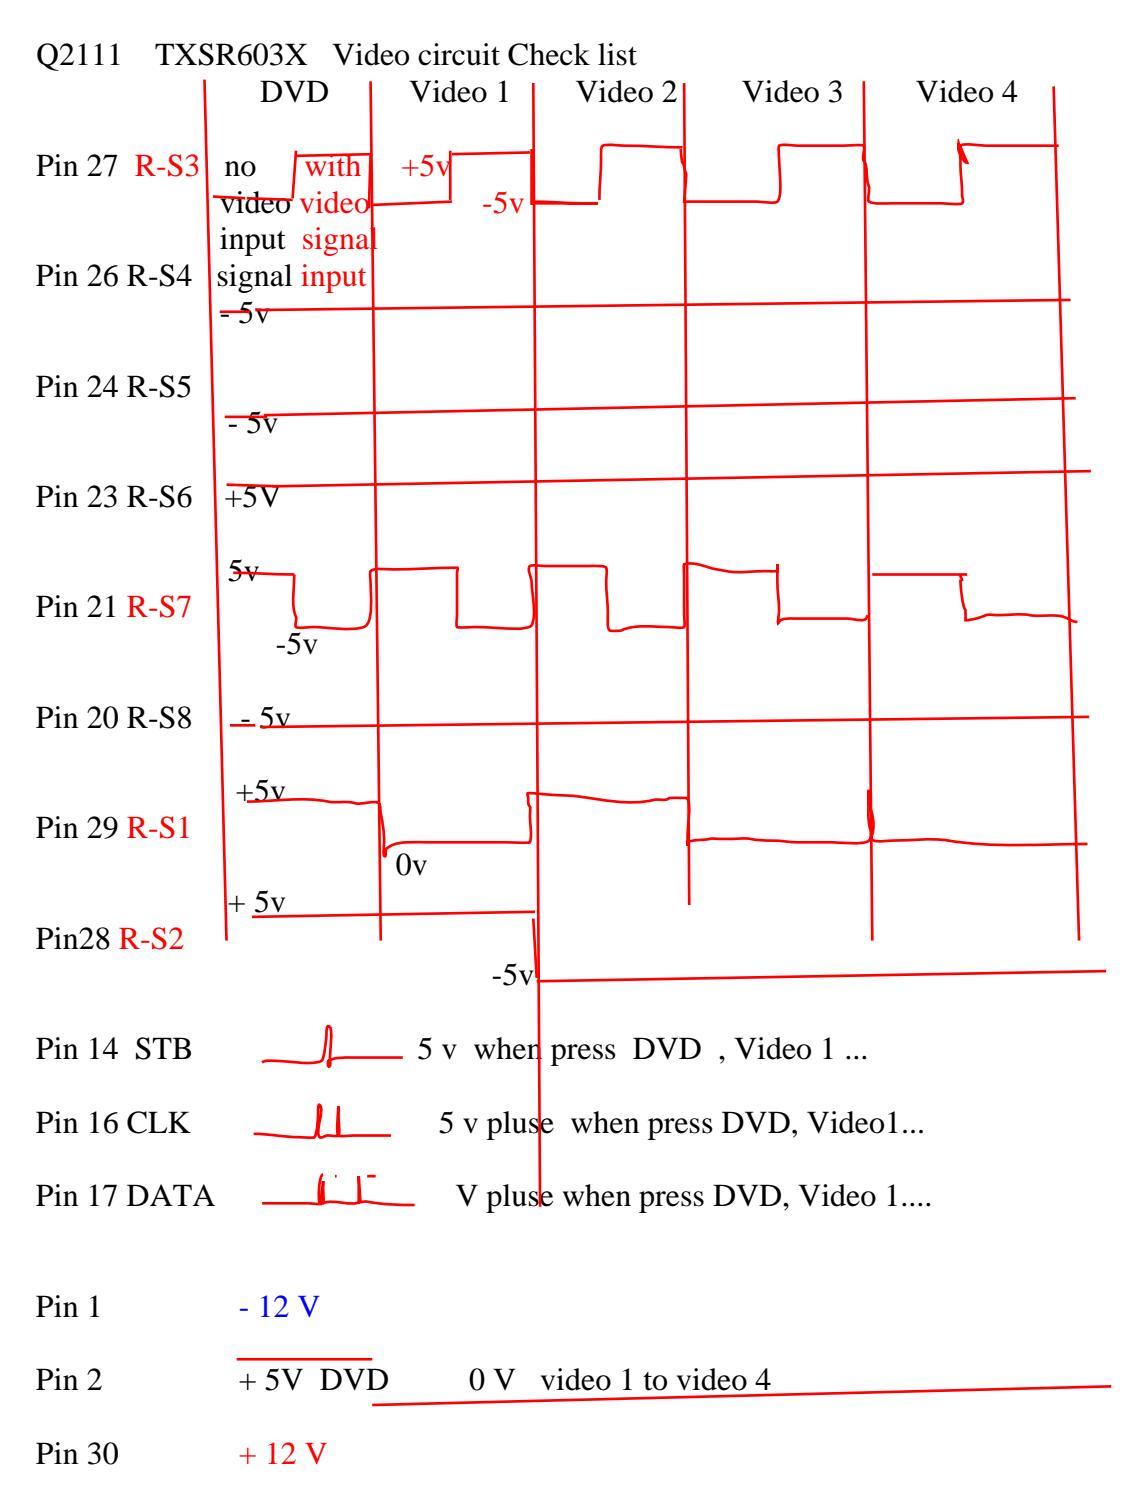
Missing +12 V - 12 V Q2111 will not work. Missing Video +5v and - 5V Check Q5654,Q5651,Q5650. Q5655,Q5652,Q5653.

When Q2111 and STB,CLK,DATA are good missing 5v R-S3 check Q2004.

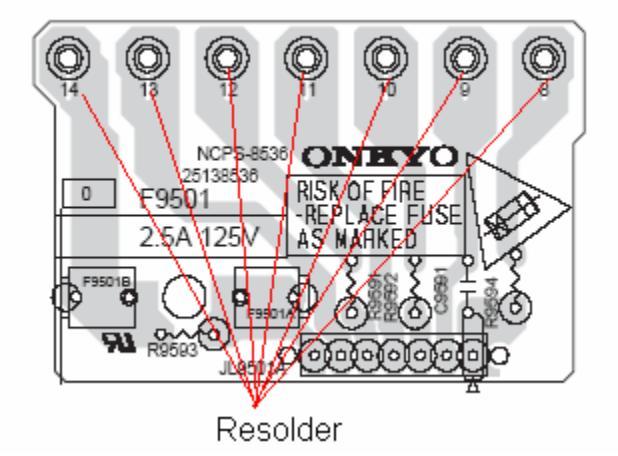
Symptom: The relays click but the set will not power ON.
Solution: Check Fuse resistor R9532 0.22 ohm 1/2 W for an open condition Lost + 12 V to Reg IC Q 5640 Unit will not turn on.
Also TXSR 503, HTR530
Unit go to Tip Ta Main Relay on and off ...on and off in 3 sec after power on. POWERD line and +10S line change up and down.
A. If audio output damage power circuit Fuse , fuse resistor open. B + B - Leaking to gound.
B . Power transformer def. or connection from main transformer to power supply circuit open.

Unit go to Tip Ta Main Relay on and off ...on and off in 3 sec after power on. POWERD line and +10S line change up and down. A. If audio output damage power circuit Fuse , fuse resistor open. B+ B- Leaking to gound. B. Power transformer def. or connection from main transformer to power supply circuit open. Apply to most Unit !! Main microprocessor was good

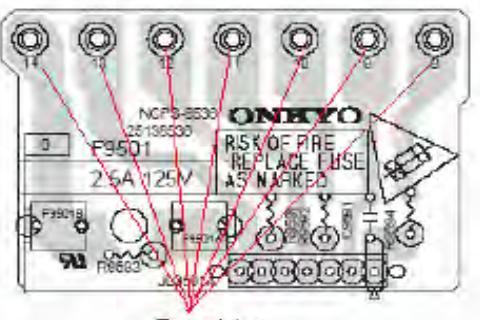
Check from bin 11 SSGND to bin 14 and 13 About 10V AC Same as SEC2-1 and SEC2-2 on JL9501A or JL9501B also P9502A and P9502 AC input to D9005 on U05 NAAF-8523 Board. When you lost any AC SEC2-1 or SEC2-2 lost +12V to Reg IC Q5640. Unit will have Tip Ta Tod relay sound . Power will not turn on.

Note: When Output transistor Def. shon out E,B,C, the F901A B+ B+ shold and F901A. will open. F8901 and F6902 may also open. Lost power supply This time press Standby / on Unit will only sound Ti Ta Ti Ta.

Solution: Check Fuse resistor R9593 for an open condition and replace if necessary. Resolder the terminal lugs on the Main transformers secondary.

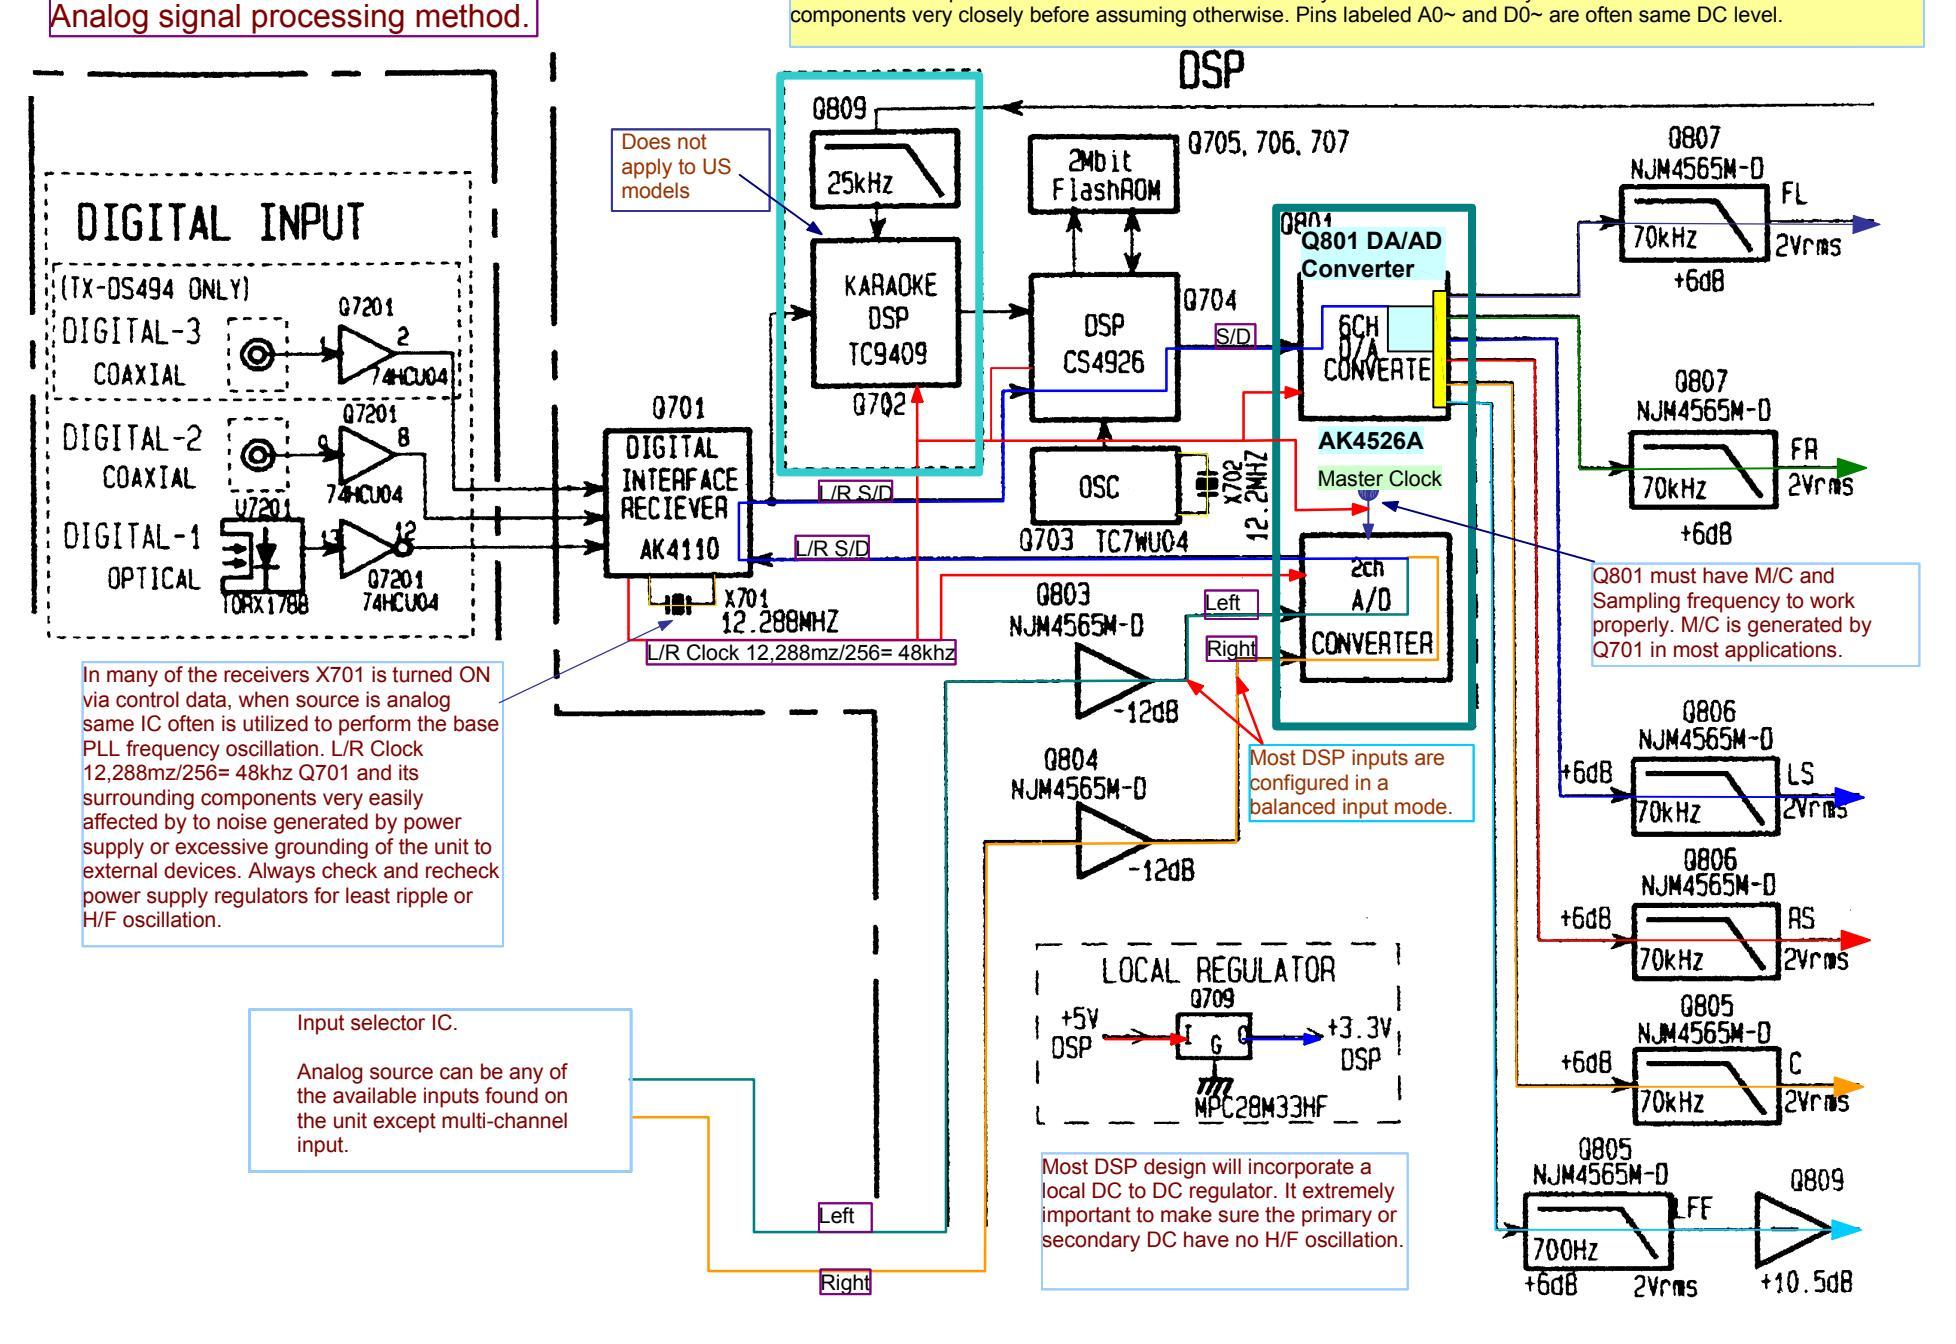
Based On TX-DS494

The most critical parts of the DSP besides the Base frequency oscillators, are the Flash-Rom's. These ROM's are often configured in an 8-bit data bus mode, A failing or loose DSP Flash ROM's could trigger, data error in which DSP may sound to break up and stutter do to mute ON-OFF. It may also mute indefinitely. It is recommended to check these components very closely before assuming otherwise. Pins labeled A0~ and D0~ are often same DC level.

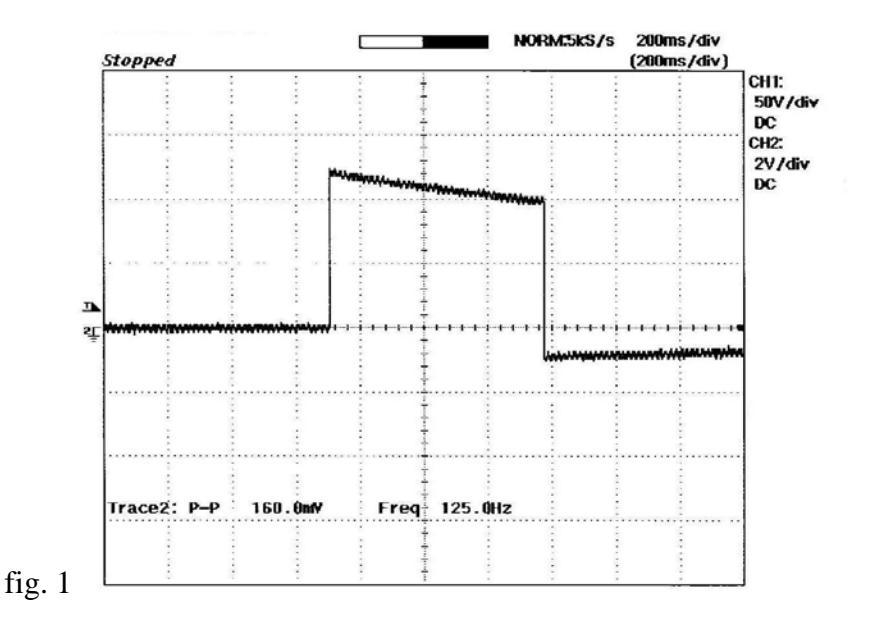
Solution: First, check coil L7002 located on the Preamp board for an open condition as outlined in previous tips and tricks publications. If the coil checks out OK, check for data communication between Microprocessor Q7008 and the Input Select IC Q301. Use an oscilloscope to check the microprocessors SELCK, SELDA and SLMUT data lines. Check the Microprocessor side of R7043 for a +5V mute pulse (fig. 1) on the SELMUT line when the front panel Listening Mode button is depressed.

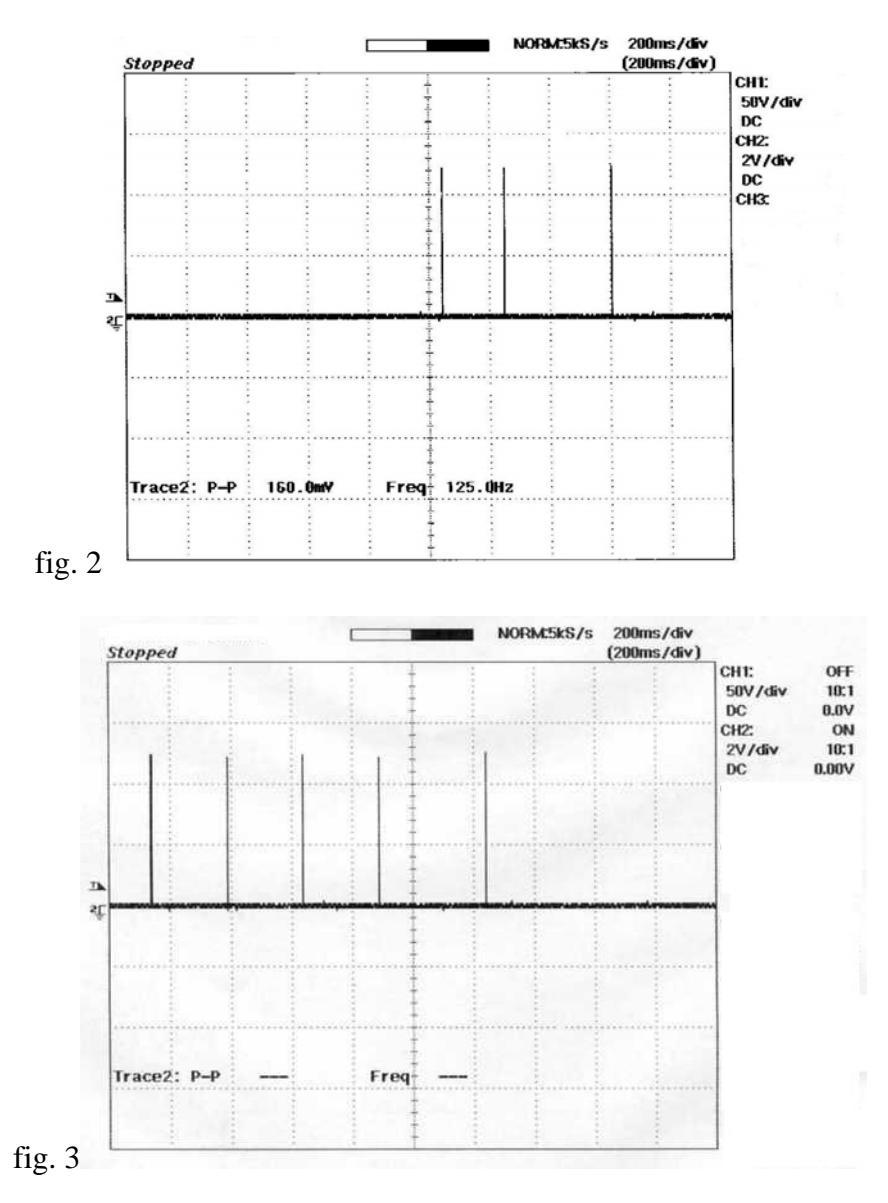
Check SELCK at R7044 (fig. 2) and SELDA at R7045 (fig. 3) for +5V data pulses when pressing the Listening Mode buttons.

If any of the microprocessors SELCK, SELDA and SLMUT data line pulses are not generated when the Listening Mode buttons are depressed, check Q7008 for "must haves": X7001 oscillation (pins 69 and 70), Reset (pin 60), VDD (pins 7, 43, 68, 71, 74 and 75) and ground (pins 4, 33, 36 ~ 39, 63 and 67). Look for DC voltage on the SELCK, SELMUT and SELDA lines. Under normal operating conditions, all three data lines should have 0VDC present. If DC is found on any of the data lines you can locate which IC is producing the DC voltage by checking resistors R7043, 7044 and 7045. If positive DC voltage is found on either side of the resistor when no front panel buttons are pressed remove the resistor from the circuit and read the open traces to see which IC is producing the +DC voltage. The IC producing the +DC voltage is defective and should be replaced.

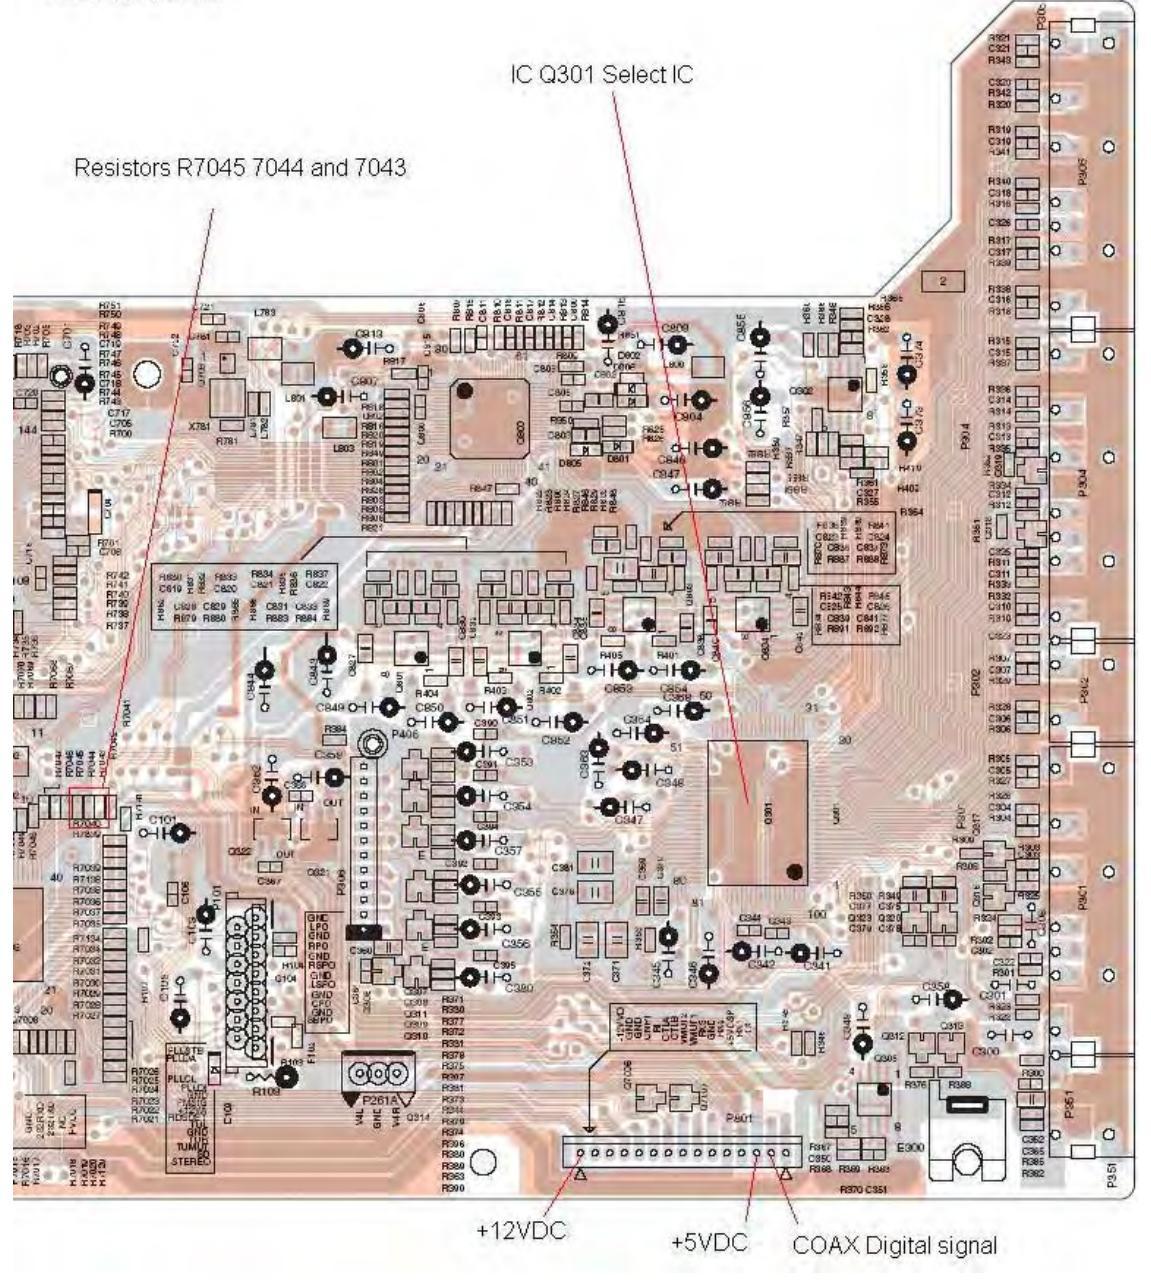
Test Points 1 of 2

Below are general test points to check when troubleshooting the Preamplifier PCB.

General Troubleshooting Test Points

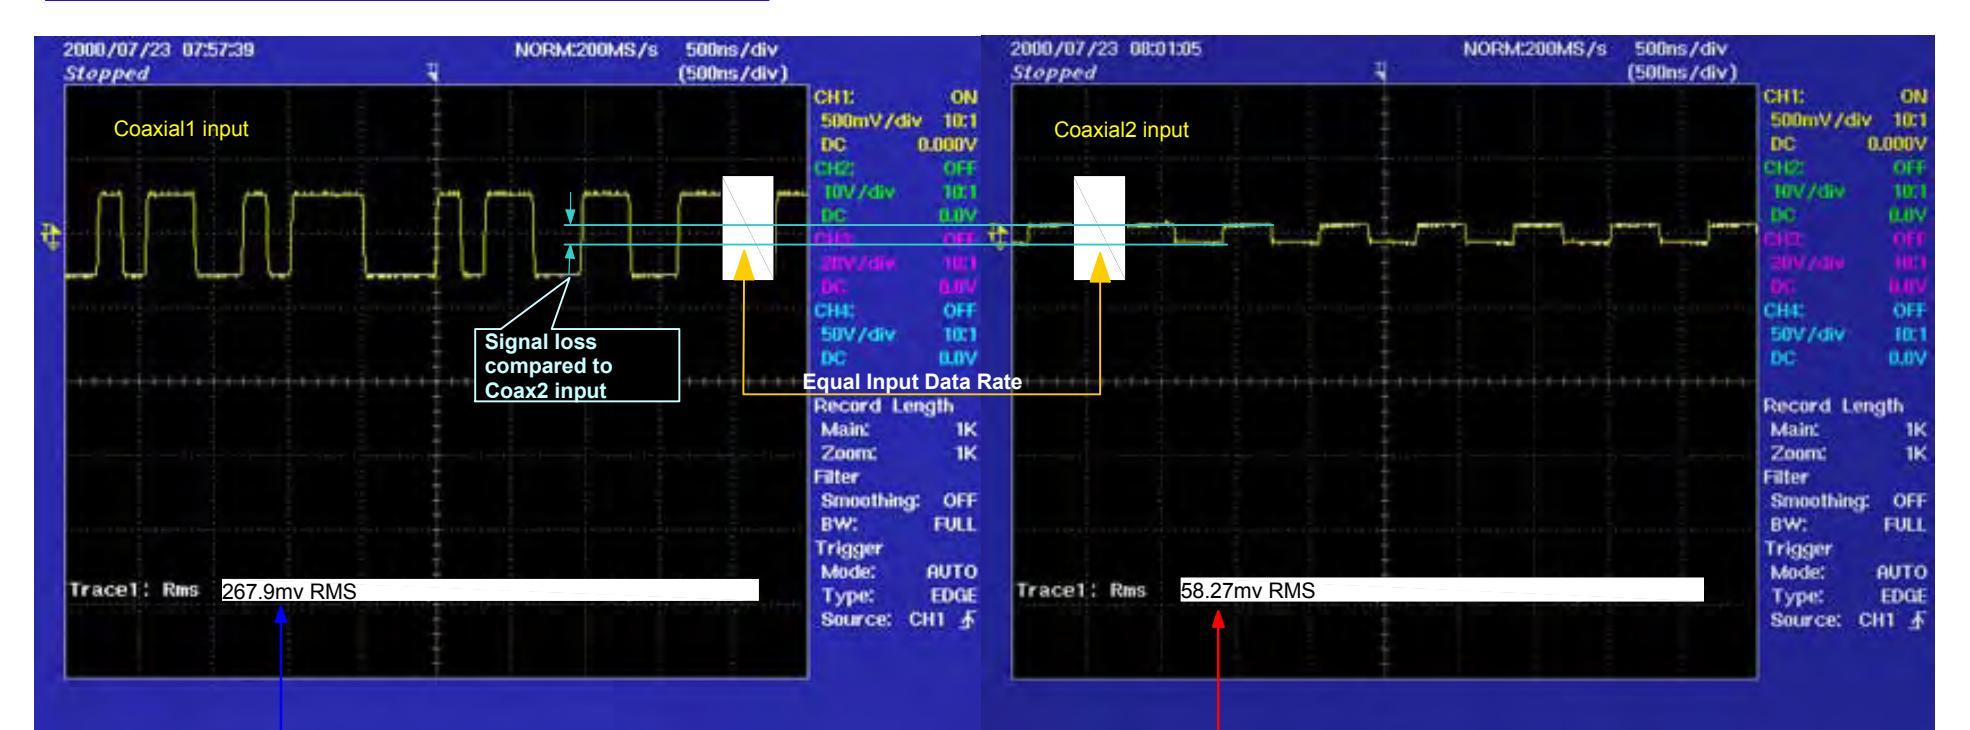
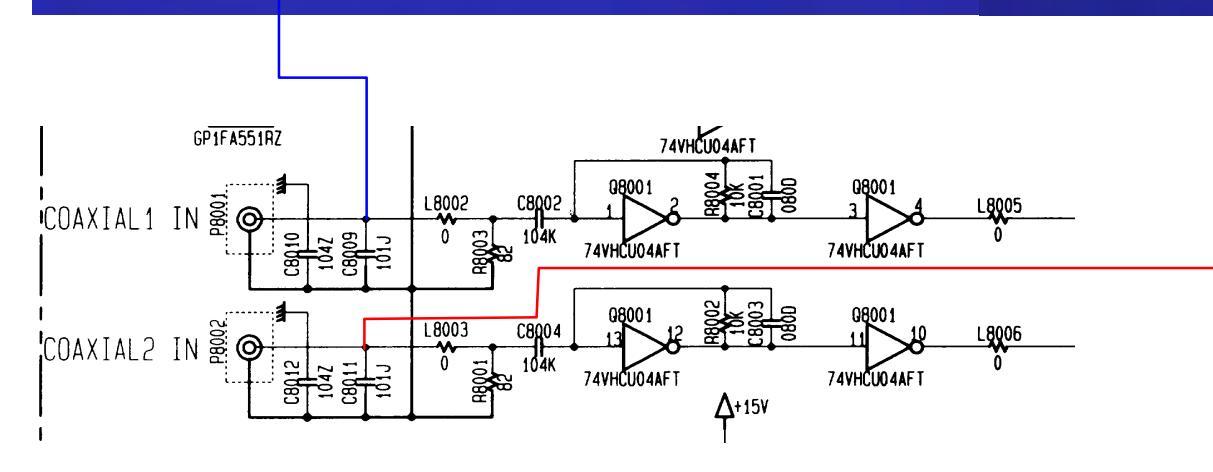
TX-DS787 DSP- COAX input:

A unit having problem with one of COAX inputs but not the other, technician may assume a DSP problem. The above wave form comparison test can be used to verify if indeed the signal is reaching the intended primary target. In this case, the input at COAXIAL2 was loaded to the ground by a defective Q8001at pin13. Pin 3 input of IC was OK and its RC components at the input gates of IC8001 were fine. The measurement was taken with the unit at power OFF state. That is because the input is passive components did not require to obtain the above reading.

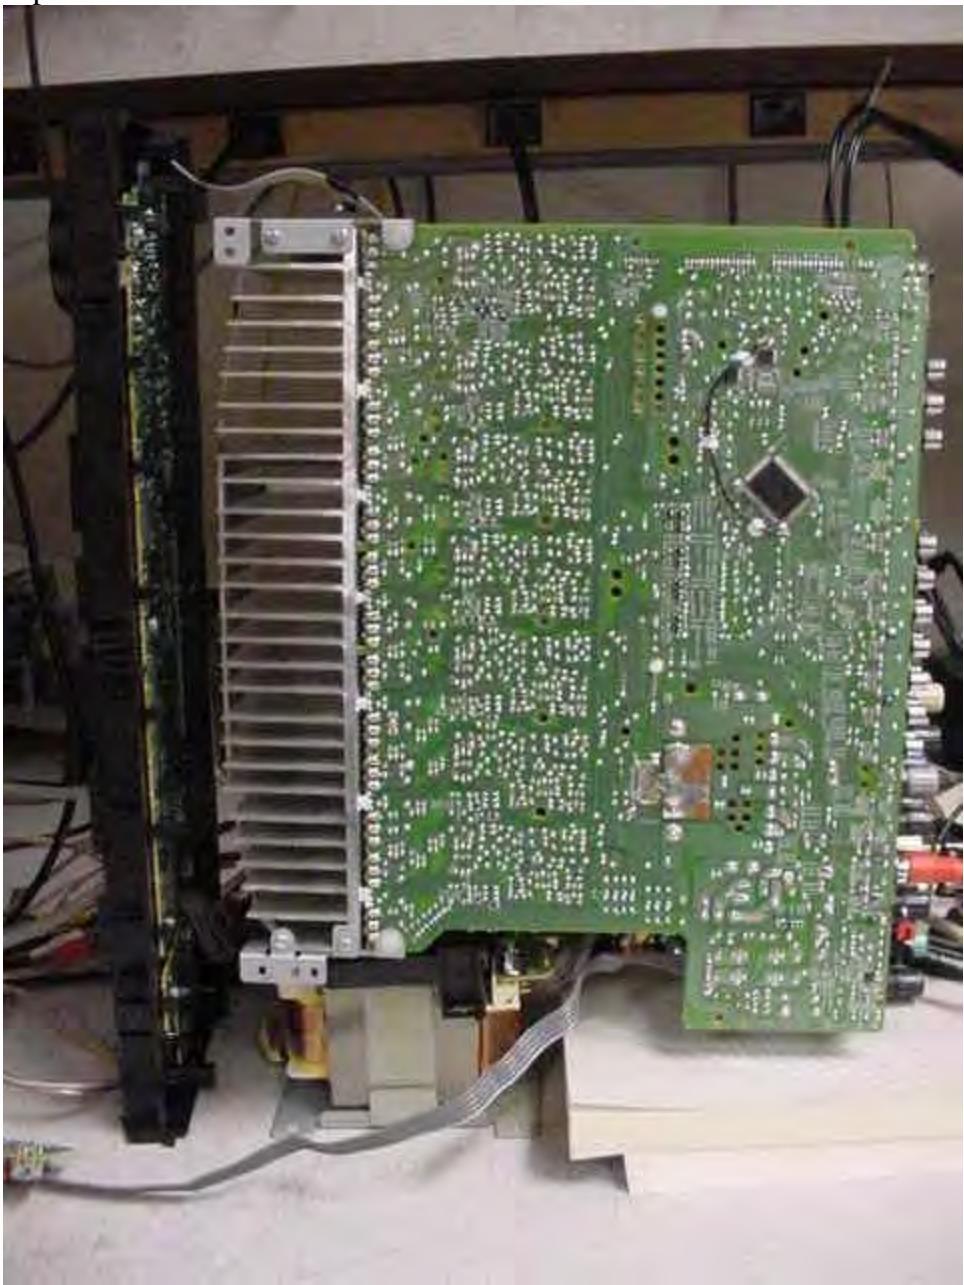
TXSR or HTR Receive. (Sample TXSR504 HTR540)

Remove screws at back panel side and sub power board. Screws at front bracket, Power transformer. Remove chassis and set unit as picture. Unit can be test and replace parts on amp board.

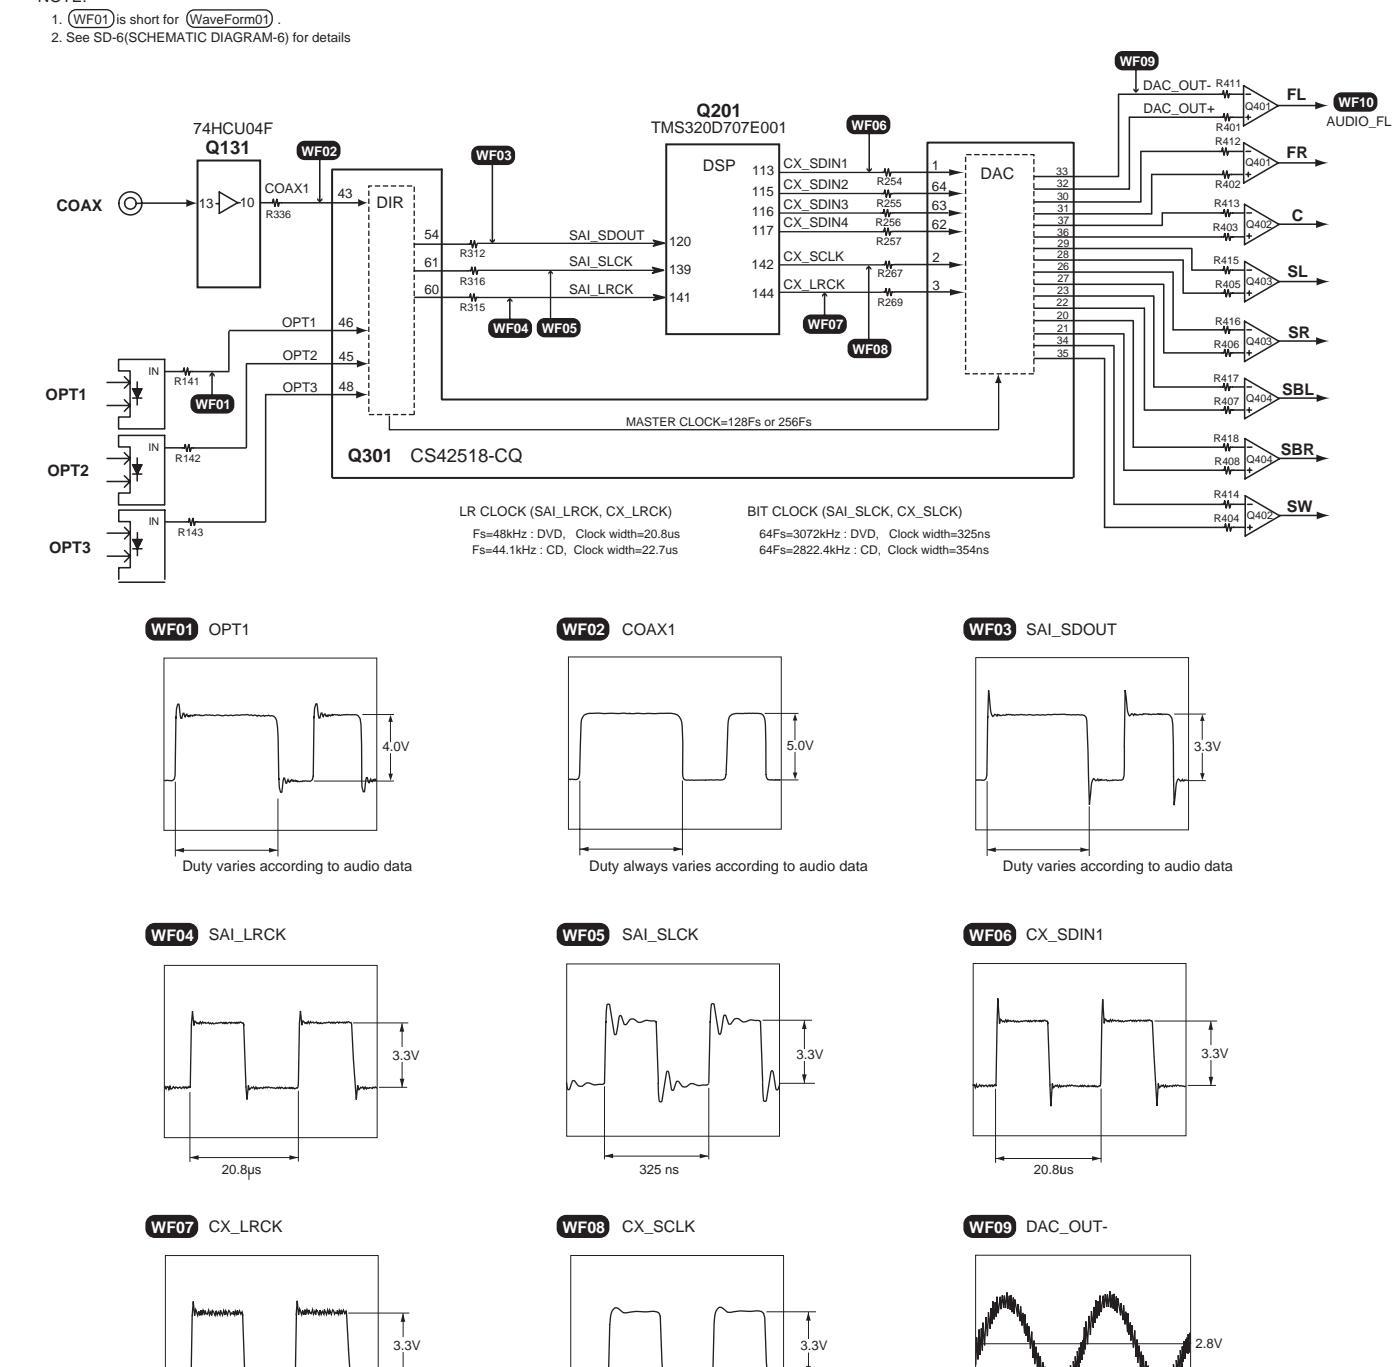
WF10 AUDIO_FL

Analog audio wave form with aliasing noise

Aliasing noise in no audio data

220mVp-p
